Reducing rail noise with acoustically optimised crossings

The noise generated by trains passing over turnouts can pose problems for railways, particularly in residential areas. Laboratory trials have shown the potential benefits of high-damping polyurethane composites, and a field test is currently underway on the ÖBB network in Austria.

Martin Quirchmair, Thomas Titze, Uwe Ossberger and Harald Loy*

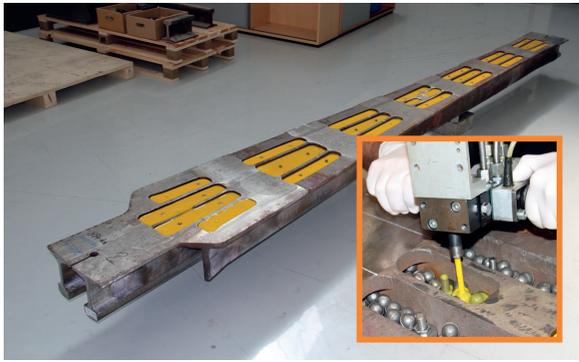
Top: Fig 1. Composite material for the damped turnout crossings used in the field test at Pfaffstätten.

The mineral filling was replaced by a metal filling, which could be introduced without any additional handling (Fig 1).

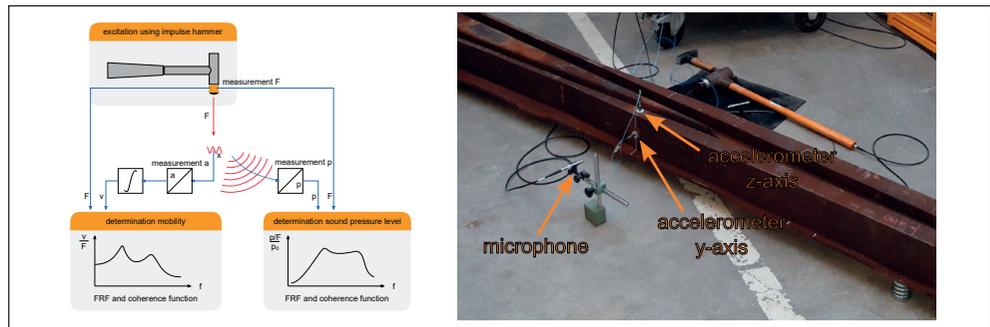
Above: Fig 2. Measurement concept and measurement set-up for the experimental modal analysis on the turnout crossing.

To ensure the best possible comparison between the laboratory and field results, we needed a measurement set-up that could be used in approximately the same form in both situations. We therefore adopted an experimental modal analysis process (Fig 2).

We decided to measure the acoustic radiation from the cast crossing as a result of an excitation using an impulse hammer. To ensure that we could measure a wide range of frequencies, we actually used two different hammers. A large hammer with a soft tip provided excitation of the lower frequency spectrum up to approximately 100 Hz, while a small hammer with a hard tip was used for excitation of the higher frequency spectrum.

Excitation took place approximately 350 mm behind the theoretical crossing point, at approximately the height of the wheel transition point. The impact on the crossing was made at an angle of 45°, in order to introduce vertical and horizontal force components simultaneously.

To evaluate the impact, we recorded the mobility represented by the vibration velocity normalised to the excitation force, as well as the sound pressure normalised to the excitation force. The vibration velocity was determined by integrating the signals of the accelerometer attached in both the horizontal (y-axis) and vertical (z-axis) directions. The acoustic radiation was measured by using a microphone at a distance of 400 mm from the crossing, level with the top of the rail.

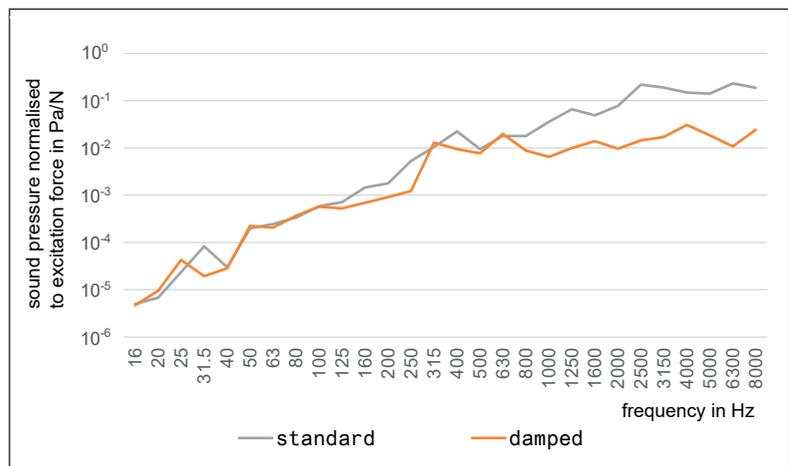
Fig 3. Excitation-normalised sound pressure of the prototype crossing when tested under laboratory conditions.

filled with the polyurethane composite material using the mineral filling, and the measurements were repeated. Fig 3 shows the measured sound pressures, normalised to the excitation force, in the third-octave spectrum.

The additional damping starts to take effect from approximately 100 Hz, while the biggest differences can be observed from a frequency of approximately 700 Hz. By forming the sum level across the measured spectrum, this results in a reduction in the excitation-normalised sound pressure of 85% due to the additional damping, under laboratory conditions.

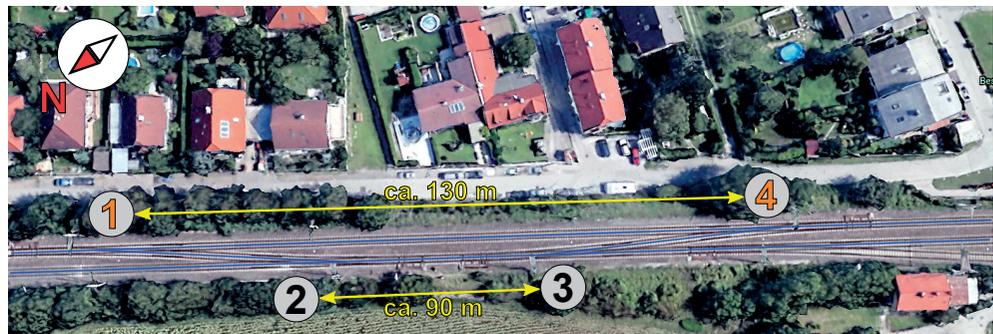
Top: Fig 4. Aerial view of the Pfaffstätten crossovers, as seen on Google Earth. Turnouts W2 and W3 are standard, while W1 and W4 are damped.

ÖBB for a practical trial on the Austrian rail network. Several locations with pairs of crossovers were shortlisted as potential sites for an in-track demonstration, but the Pfaffstätten crossovers on the Südbahn main line in Niederösterreich offered the most favourable conditions (Fig 4).

This pair of crossovers is equipped with type 60E1 – R500 – 1:12 turnouts manufactured by Voestalpine Railway Systems. Conventional crossings were used on the westbound track (turnouts W2 and W3), while those for turnouts W1 and W4 on the eastbound track were fitted with damping. As explained earlier, we changed from the mineral filling material used in the laboratory tests to a metal filling material in order to improve handling and recycling.

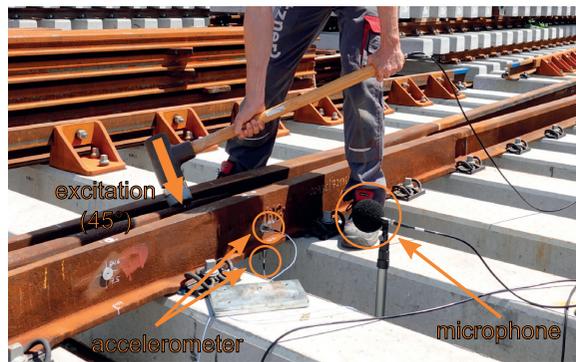
Above: Fig 5. Measurement setup for the pre-installation tests at the Voestalpine plant in Zeltweg.

Unlike the standalone tests in the laboratory, the pre-installation tests were done with crossings fitted to the bearers and supported on the turnout assembly station at the plant. In this configuration, the cast crossings were no longer able to oscillate freely upon excitation, but were restricted in their degrees of freedom (Fig 5). For comparison purposes, measurements were performed on one standard turnout (W2) and one damped crossing (W1).

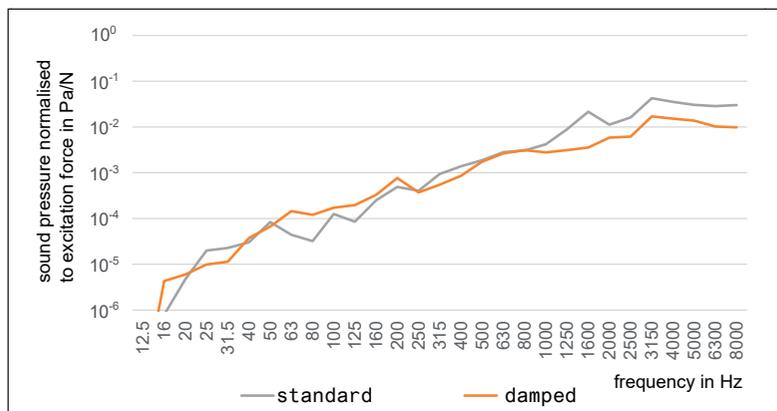
Fig 6. Excitation-normalised sound pressure on turnout crossings W1 (damped) and W2 (standard) as tested in Zeltweg.

As anticipated, Fig 6 shows that the differences in the normalised sound pressures were lower than for the freely oscillating crossing tested in the laboratory, because additional damping had been introduced into the system through the coupling of the crossing to the turnout bearers. The sound measurements were somewhat hindered

by background noise from the plant operations, but a 60% improvement in the excitation-normalised sound level was determined in the sum level, subject to the uncertainty introduced by the ambient conditions.

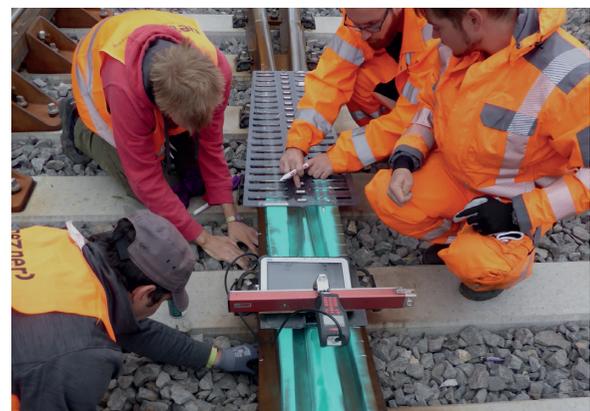
Fig 7. Voestalpine staff checking the turnout crossing geometry at Pfaffstätten prior to the in-track noise measurements being recorded.

in September of that year. The actual turnout geometries were recorded by Voestalpine before the trial (Fig 7) to confirm that all four crossings still had their optimum geometry at the time the measurements were taken.

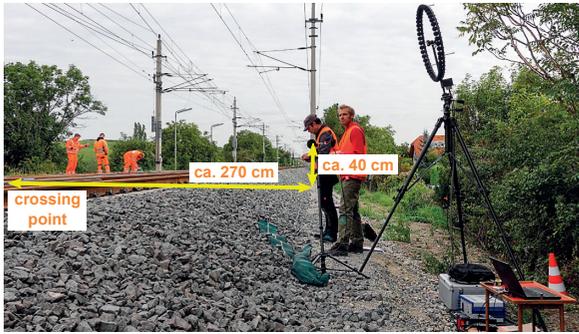
Fig 8. Setting up the measurement equipment to record the noise of passing trains during the field trials at Pfaffstätten.

Acoustic measurement with a single microphone could not be carried out strictly in accordance with DIN EN ISO 3095 due to the local conditions, including the surrounding vegetation and the embankment location, which meant that the recording distances had to be reduced considerably. Fig 8 shows

how the measurement equipment was set up on site.

In addition to the single microphone for sound measurement, we also used an 'acoustic camera' to record the passage of the train. This used a microphone array positioned behind the single microphone.

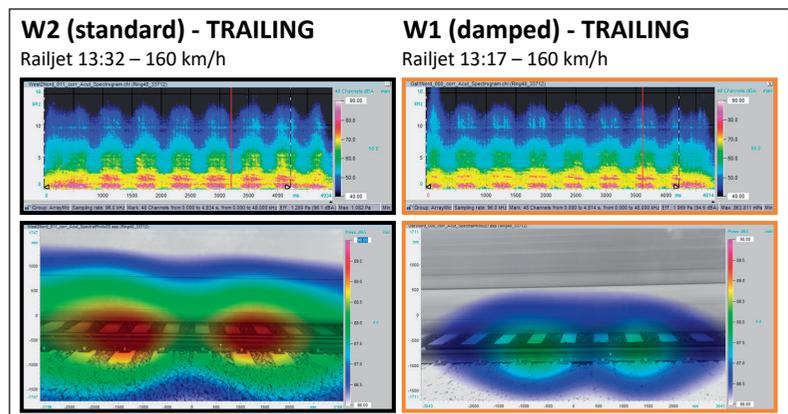
Below: Fig 9. Pass-by noise level of a Railjet trainset passing over the facing turnouts W3 (standard) and W4 (damped) and the trailing turnouts W1 (damped) and W2 (standard). (ref p0 = 2 x 10⁻⁵ Pa)

Fig 9 shows the results as recorded using the single microphone. The damped crossings showed a slight reduction of 1-9 dB in the average sound pressure level for the two facing turnouts, but only 0-2 dB for the trailing turnouts. Due to the insufficient number of passing trains, wide scatter bands within the same vehicle class and minor differences in the averaged spectra, in our evaluation we considered that both situations were approximately the same.
